# Influence of Road Feature Variables on Accident Rate in Cameroun. Case study: The road triangle Yaounde-Douala-Bafoussam-Yaounde Highway.

Jean François Wounba<sup>1</sup>, Pretty Ngikem Ngemoh<sup>2</sup>, Stephen Fondzeyuy Kome<sup>3</sup>, George Nkeng Elambo<sup>4</sup>

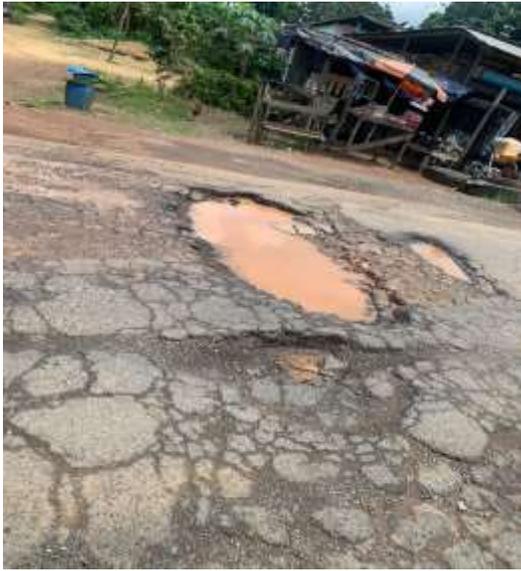
Globally, the state of the road surface on the N°5 road is catastrophic. This can be considered a contributing factor to the road accidents occurring on this road since a great part of the road is cracked, some areas delaminated, some with very deep pot holes, others experiencing rut and depression and shoulder drop off. This is due to the fact that with time, traffic, weather conditions and ground conditions expose the road surfaces to wear and tear. Ruts, cracks and unevenness in the road surface reduce driving comfort and can be a traffic hazard. Ruts and cracks in the road surface may make it more difficult to keep a motor vehicle on a steady course. Large pot holes in the road surface can damage vehicles and lead to the driver losing control of the vehicle. To avoid this, some drivers perform maneuvers to avoid areas where the road surface is not convenient by moving to the lane reserved for the opposing traffic which might be a cause of head-on collisions. All these call for high rehabilitation works on the N°5 road.

Figure 2. Delaminated and cracked road filled with potholes at Bomono

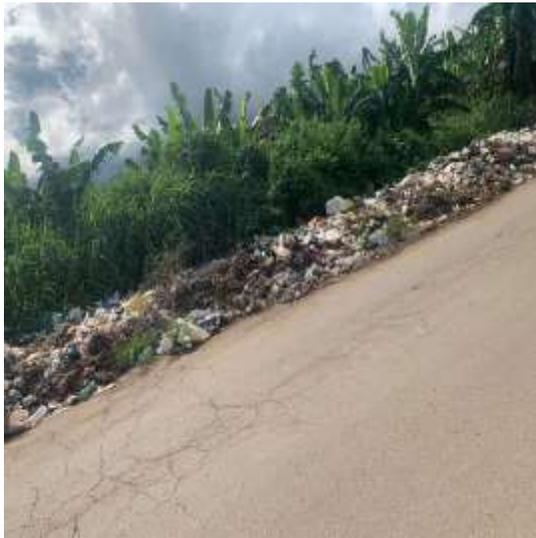
At some segments of the N°5 road (precisely at Nkongssamba) the shoulder width was occupied by dirt which turned to equally occupy a portion of the lane width thereby reducing the available space and presenting risk for side-swap collision.

Figure 4. (a) Shoulder lane filled with dirts around Nkongsamba entrance, (b) insufficient shoulder width

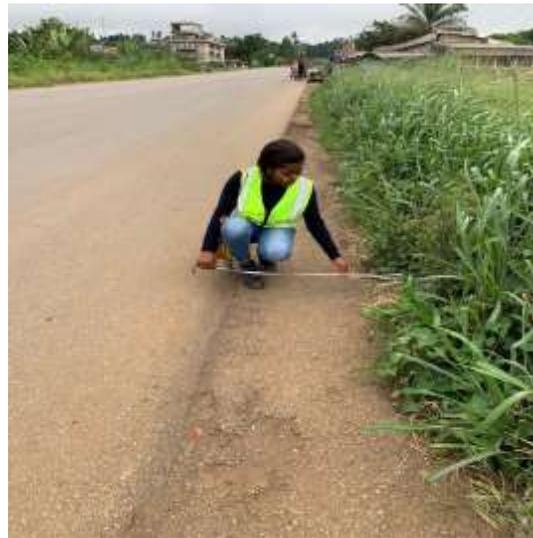
(b)

The shoulder widths where present on the N°3, N°4 and N°5 roads are reported to be an average of 1.75 m, 1.2 m, 1 m respectively. However, considering the size of the articulated trucks that have a width of approximately 2.5 m, these shoulder widths are considered very insufficient as most vehicles when they encounter a breakdown, are forced to occupy a part of the lane width thus visibility hindered and risk of head-on collision.

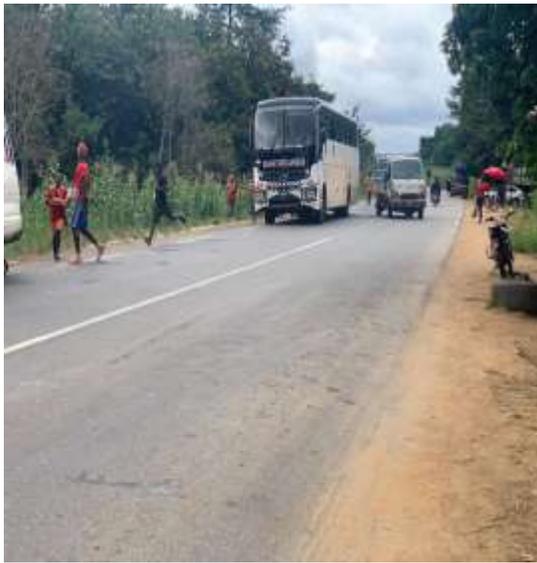
Figure 5. (a) Road lane occupied by a parked bus around Sombo, (b) Boumyebel intersection absence of signalisation and very poor channelization

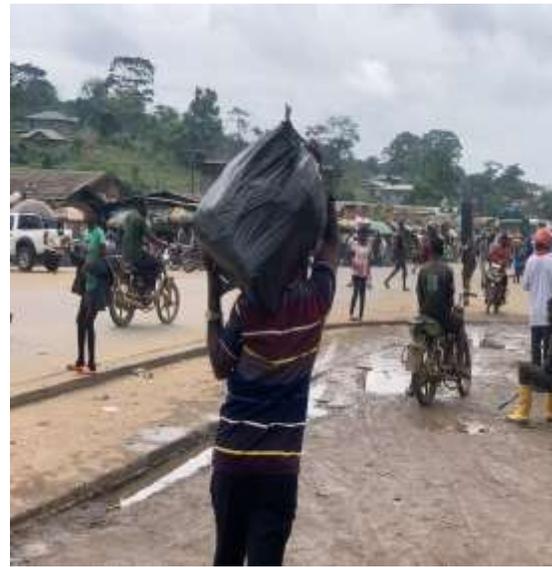
(b)

At the Boumyebel intersection, there is a notable absence of road signalizations. Considering the high population density and activity level at this point, the risk of collision between vehicles and pedestrians is significantly increased
